DEPARTMENT OF TRANSPORTATION**DIVISION OF ENGINEERING SERVICES**

Contract #: 04-0120F4Cty: SF/ALA Rte: 80 PM: 13.2/13.9File #: 69.28**WELDING INSPECTION REPORT****Resident Engineer:**Pursell, Gary**Address:** 333 Burma Road**City:** Oakland, CA 94607**Report No:** WIR-004074**Date Inspected:** 23-Sep-2008**Project Name:** SAS Superstructure**OSM Arrival Time:** 1400**Prime Contractor:** American Bridge/Fluor Enterprises, a JV**OSM Departure Time:** 2300**Contractor:** Zhenhua Port Machinery Company, Ltd (ZPMC), Changxing Island **Location:** Shanghai China**CWI Name:** Li Yang**CWI Present:** Yes No**Inspected CWI report:** Yes No N/A**Rod Oven in Use:** Yes No N/A**Electrode to specification:** Yes No N/A**Weld Procedures Followed:** Yes No N/A**Qualified Welders:** Yes No N/A**Verified Joint Fit-up:** Yes No N/A**Approved Drawings:** Yes No N/A**Approved WPS:** Yes No N/A**Delayed / Cancelled:** Yes No N/A**Bridge No:** 34-0006**Component:** Tower**Summary of Items Observed:****89M Mock-up**

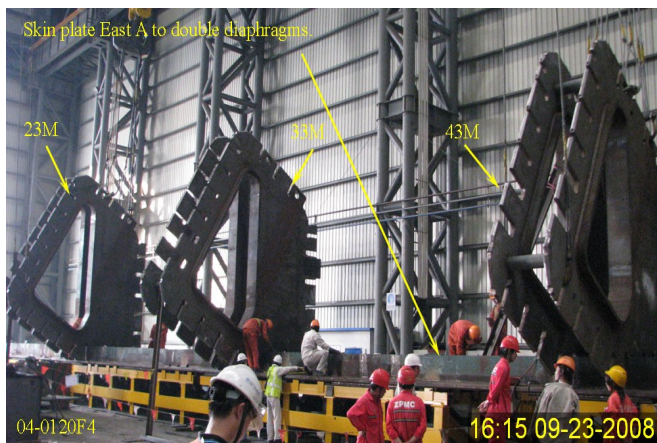
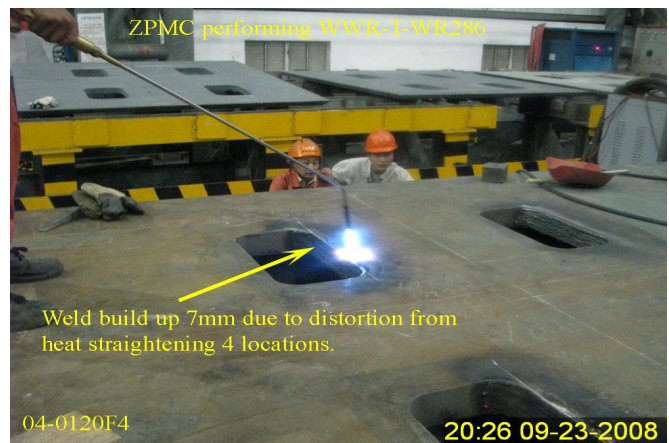
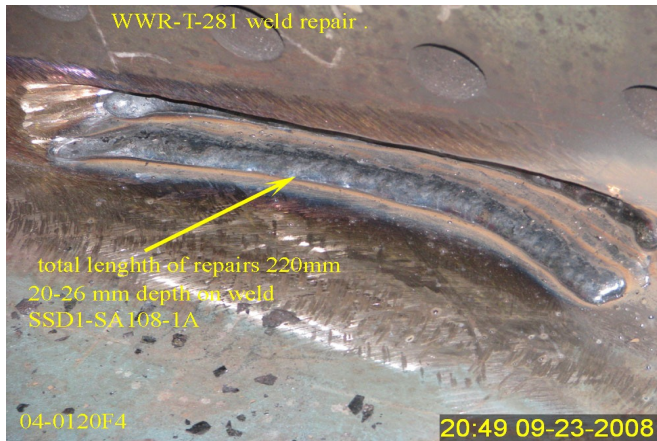
This QA inspector observed ZPMC performing weld repairs for the following locations and WWR numbers. 1) WWR, T-WR286 for the south tower skin A where the 4 holes in the skin plate are to receive the double diaphragm plates. These areas were distorted during the heat straightening process and the measurements were now out tolerance. ZPMC used the FCAW process to add 7mm of weld metal to the inside face at all 4 locations to machine back to a 5mm depth. 2 welders were noted at this location 1) Yu Yonglai- 048378 and 2) Zhu

Zhongyun- 057194. The welding position was in the 2F position for fillet welding under WPS-345-FCAW-2G(2F)-Repair. ZPMC's CWI Xu Le Feng was observed as being onsite for this procedure and monitoring the parameters and progress. 2) WWR number T-WR281 for skin E weld number SSD1-SA108-1A. This area under repair was due to ZPMC UT department finding rejectable indications that required removal and repair. The welder for this process was Jiang Zhou-040261 under WPS-345-2G (2F)-Repair. The depth of excavation was approximately 20-26mm with a length 220mm. The FCAW process was being utilized for this location. Also Noted in tower shop bay 1 was the SAW welding SSD1-SA163 for the CJP and PJP weld splice. The CJP splice was under WPS-B-T-2221-B-U3c-S-2 at the following locations and welder ID number, A/D-27A welder 050295, A/D-19A welder 050295, A/D-20A welder 040414 and B/D-4A welder 040414. For the PJP weld splice locations and welder ID numbers are C/D welder 050295, A/D-23 welder 050295, A/D-25 welder 040414 and C/D-5 welder 040414. ZPMC had QC personnel onsite along with CWI Li Yang for the monitoring of parameters and progress.
